DRUG ALERT

CLASS 4 MEDICINES DEFECT INFORMATION

Inhixa solution for injection in pre-filled syringe 2,000 IU (20 mg) in 0.2 mL; 4,000 IU (40 mg) in 0.4 mL; 6,000 IU (60 mg) in 0.6 mL; 8,000 IU (80 mg) in 0.8 mL; 10,000 IU (100 mg) in 1.0 mL

▼Inhixa (enoxaparin sodium) solution for injection: rare cases of self-activation of safety device in unopened, unused pre-filled syringes.

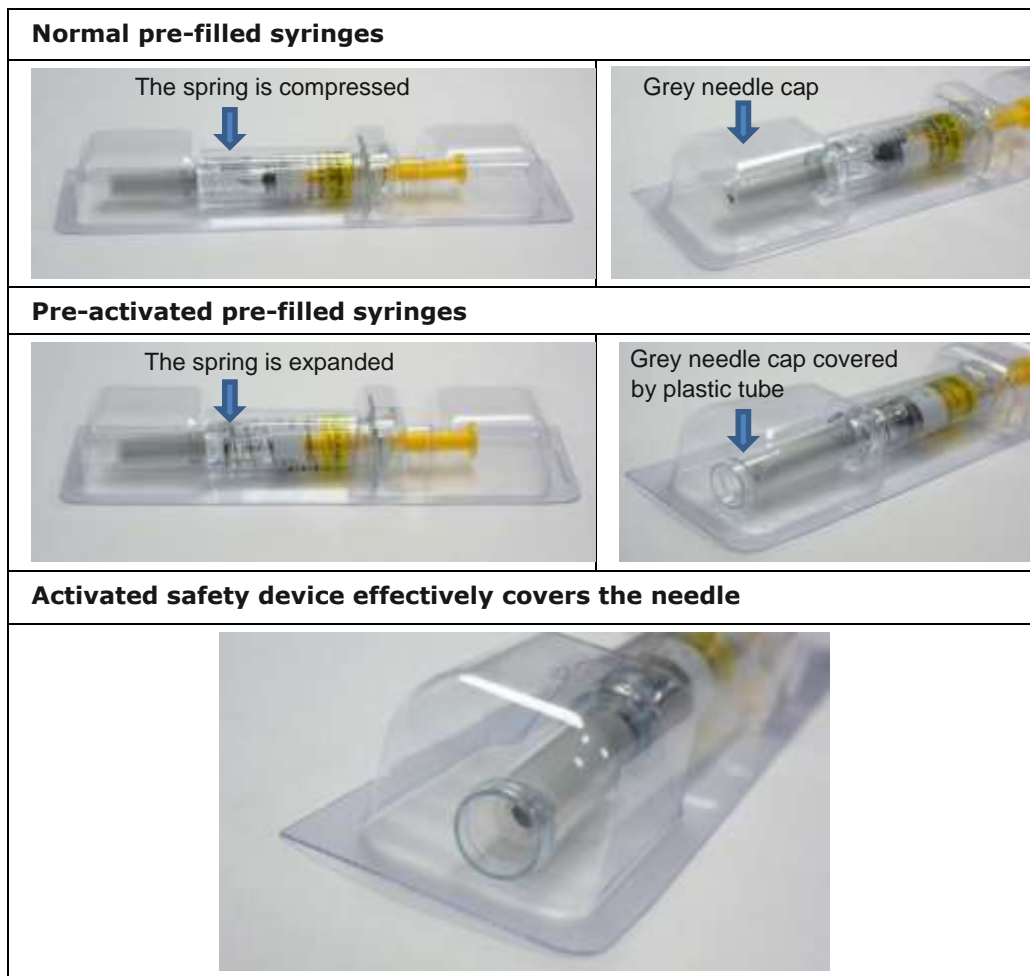
Figure 1. Pre-activation is easily detectable:

- In very rare cases, premature self-activation of the safety device has been observed in unused, unopened pre-filled Inhixa syringes (see Figure 1 below); when premature activation has occurred, medicine administration is not possible.
- **Pharmacists should visually check all devices before dispensing Inhixa and make sure they have sufficient stock of Inhixa available as replacements.**
- There is negligible risk of needle stick injury when handling these pre-filled syringes, since the safety device ensures full coverage of the needle; the risk of a patient missing a dose can be minimised by the above checks and advice to patients.

Self-activation of the safety device has been observed rarely in unused, unopened blisters containing Inhixa pre-filled syringes. An analysis has shown that the incidence of self-activation is 0.001%. To date, the issue has not been associated with any adverse event or risk to public health.

The possibility of needle stick injury is negligible as the safety device ensures full coverage of the needle. With regard to the potential risk of missing a dose, this is easily manageable: as the product is presented in transparent blisters, self-activation is visually apparent and easily detectable before dispensing and use. Moreover it is not necessary for pharmacists to open the blister packs to perform a visual check of syringes blisters before dispensing.

Detailed investigation by the manufacturer has pinpointed the root cause, corrective and preventive actions have been implemented to prevent recurrence of the issue.

- Pharmacists should visually check all Inhixa syringes before dispensing to check if they are affected by the self-activation defect as shown in the DHCP diagrams. Do not open the syringe blisters.
- Individual syringes that are affected by the self-activation defect should not be dispensed to patients.
- Pharmacists should make sure they have sufficient stock of Inhixa available as replacements.
